# ENVIRONMENTAL AUDIT OF THE SITES IMPACTED BY THE “PROBO KOALA” TOXIC WASTE DUMPING IN ABIDJAN, CÔTE D’IVOIRE

# SITE 15: ABOBO SAGBÉ

Site name: Abobo Sagbé  
UN Environment site reference no: 15

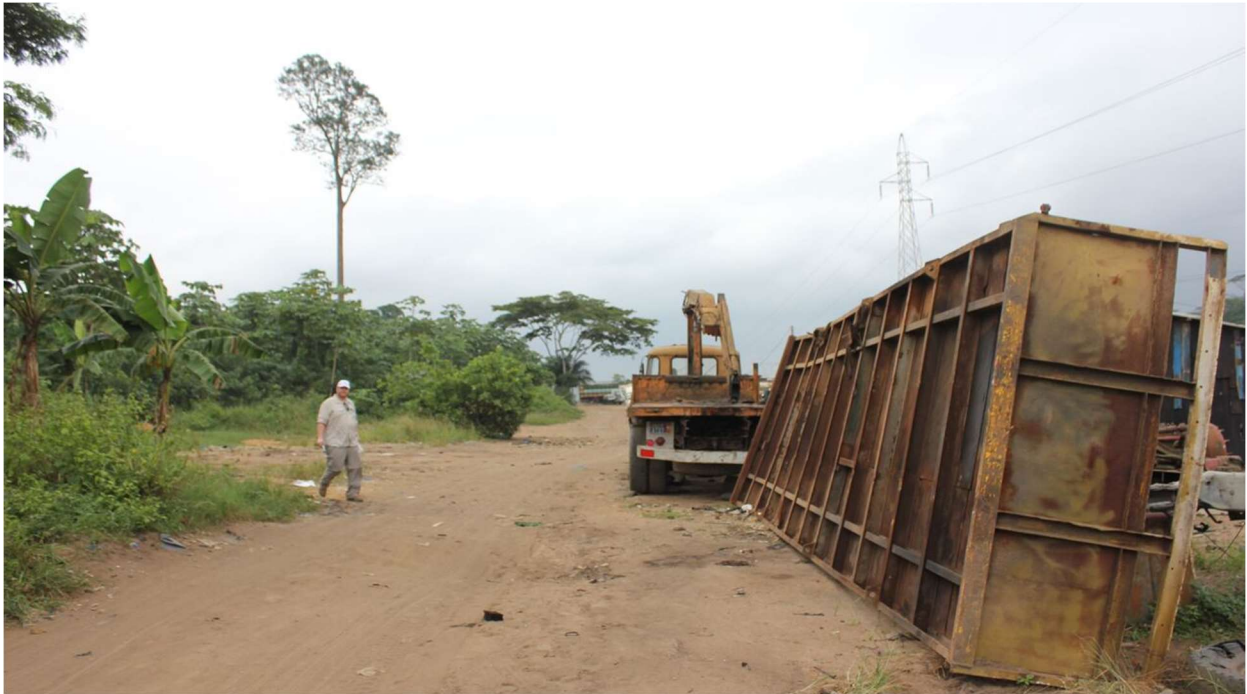
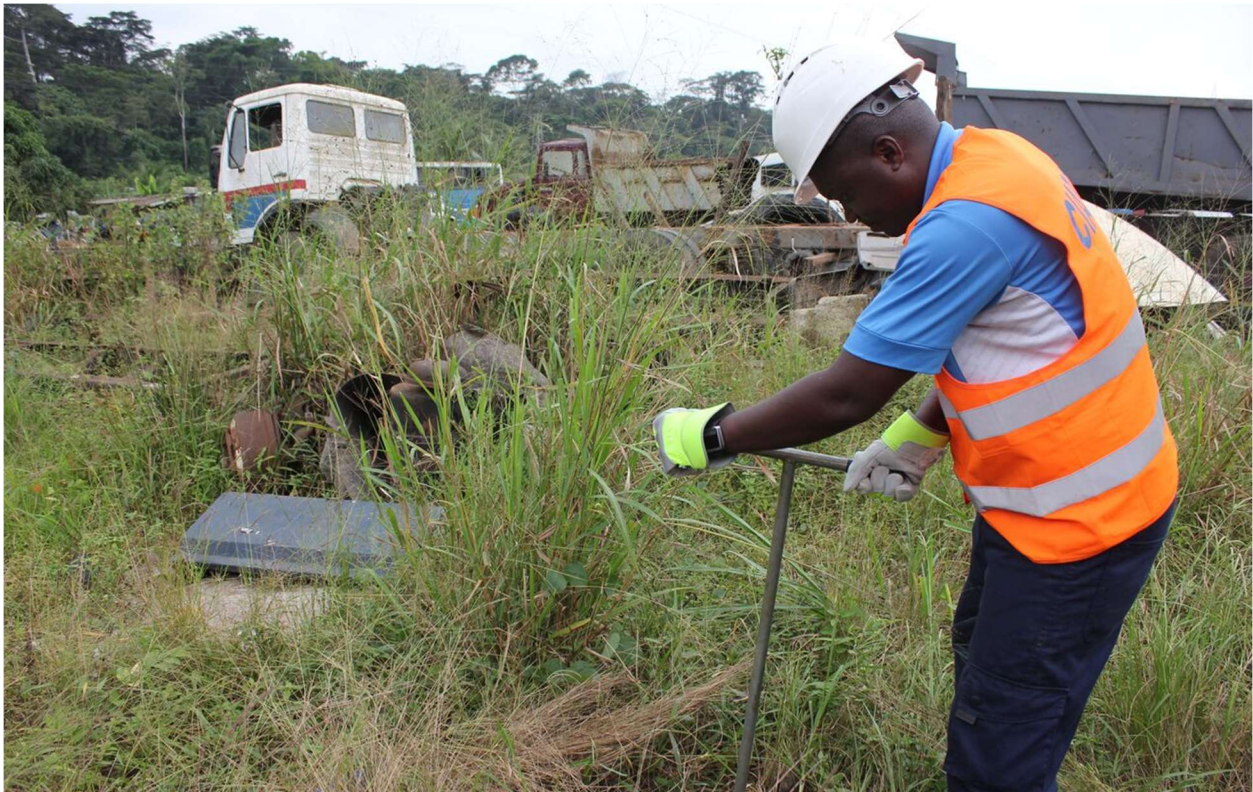
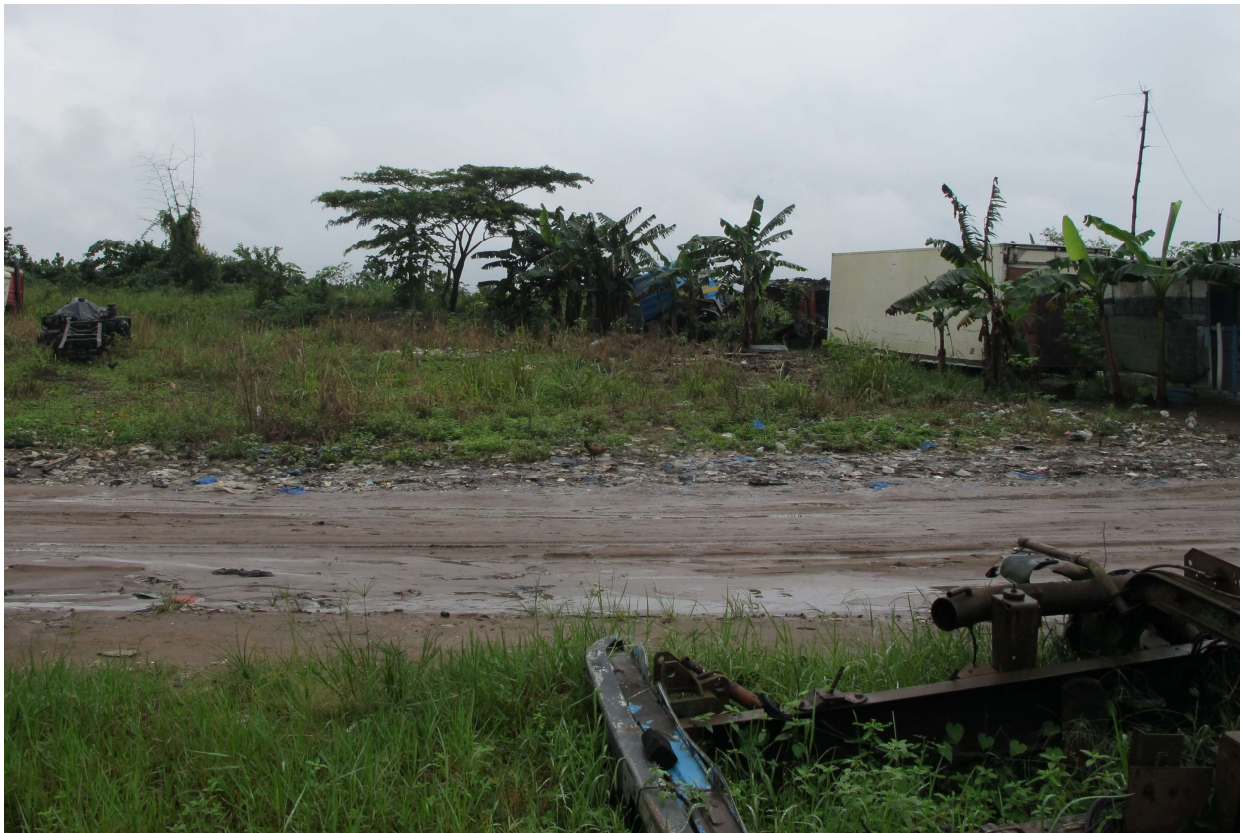
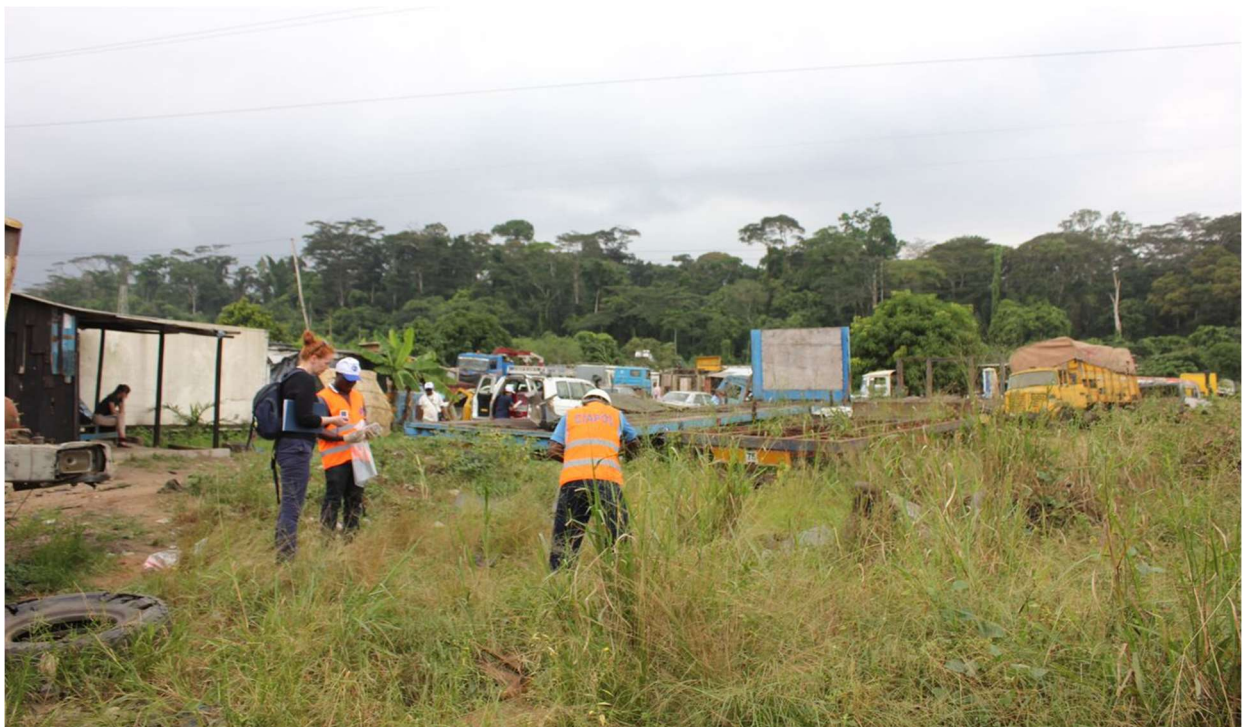
### Site Photo

This spill site is located within a vast expanse of informal and unregulated small businesses including mechanics, spare parts dealers, auto body shops and other vehicle-related workshops located in the Abobo area, at the edge of the Banco National Park. Wastes from the Probo Koala are reported to have been dumped onto an open plot of land, which at the time was situated at a distance from the workshops, but is now surrounded by them. Clean-up works undertaken by Trédi in 2006-2007 included excavating the surrounding soil for off-site treatment, with the remaining void was backfilled with clean soil.

The laboratory results show that the current concentrations of the contaminants of concern in soil are all below the standards set by the Government of Côte d'Ivoire for clean-up. Likewise, hydrocarbon levels in the sample analysed are well below Dutch intervention values. Furthermore, the pH values are not in the caustic range (9 or above), demonstrating that the impact of the disposal of caustic substances can no longer be detected. No further action is therefore needed on this site to remediate the soil impacts of the 2006 toxic waste dumping from the Probo Koala.
