# ENVIRONMENTAL AUDIT OF THE SITES IMPACTED BY THE “PROBO KOALA” TOXIC WASTE DUMPING IN ABIDJAN, CÔTE D'IVOIRE

# SITE 16 : PLATEAU DOKOUI 1

Site name: Plateau Dokoui 1  
UN Environment site reference no: 16

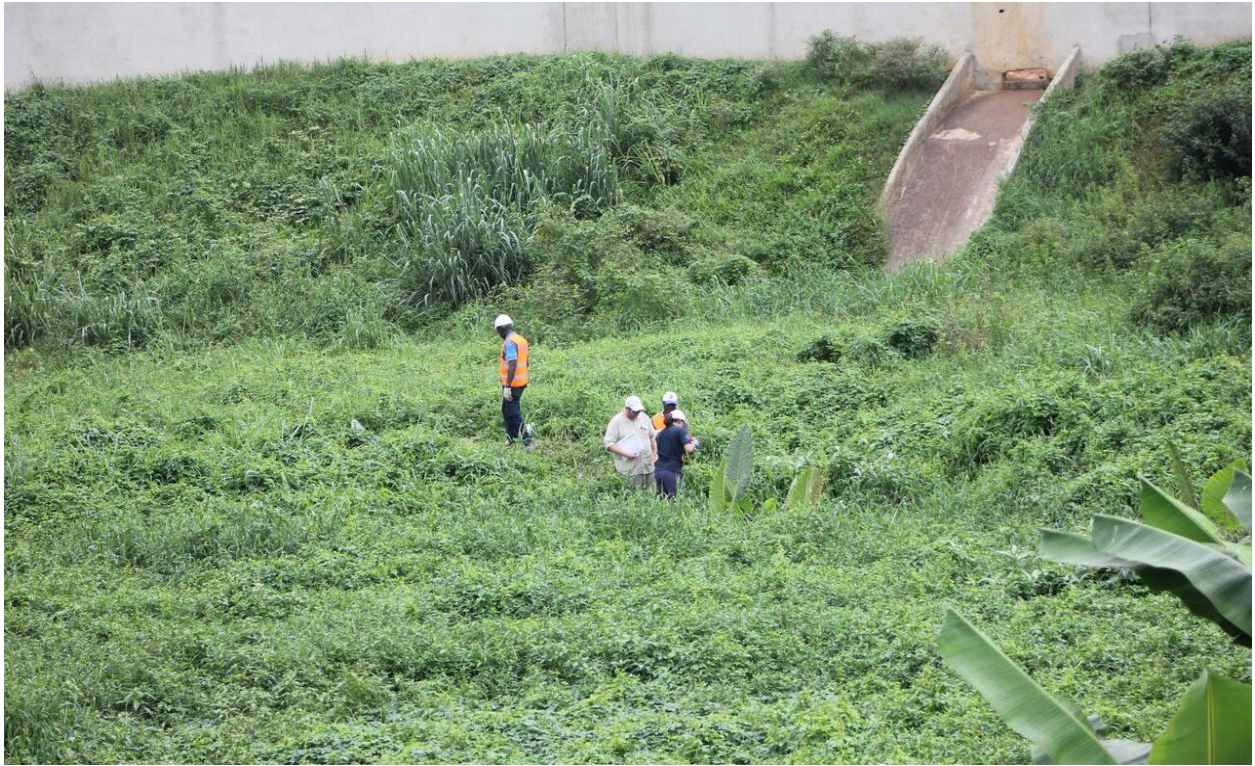
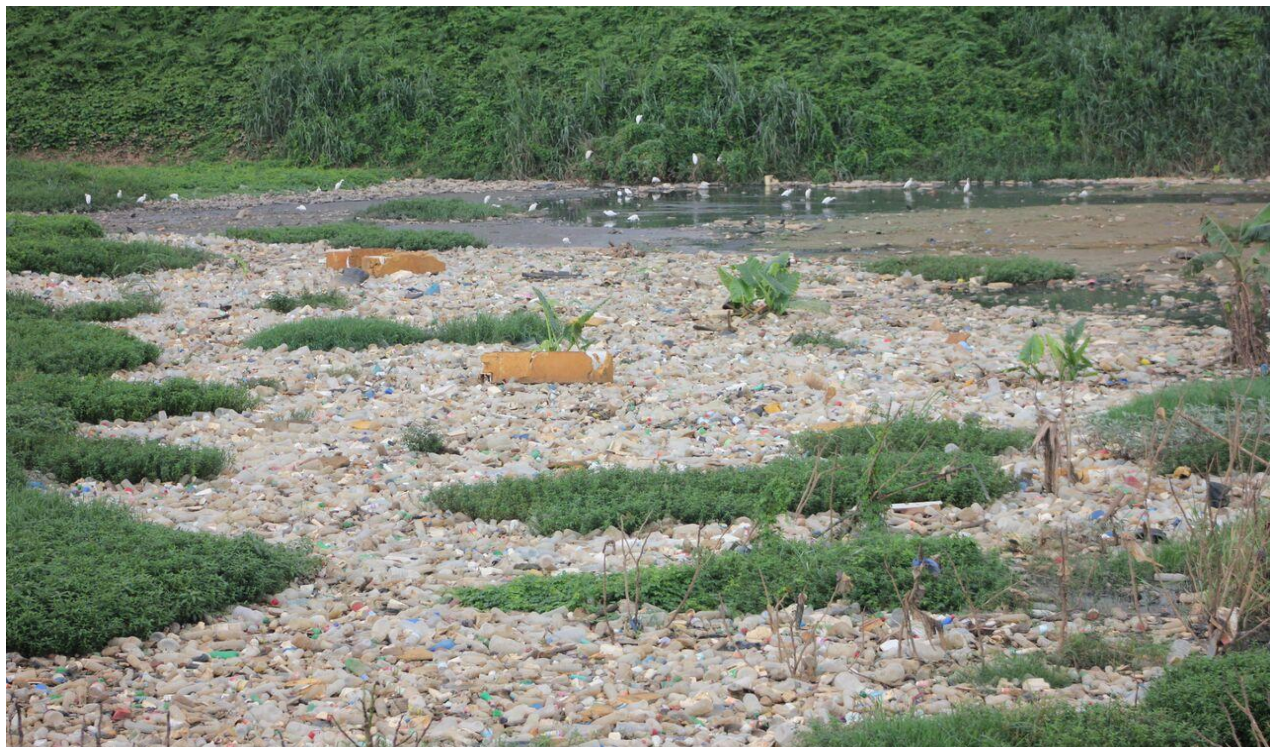
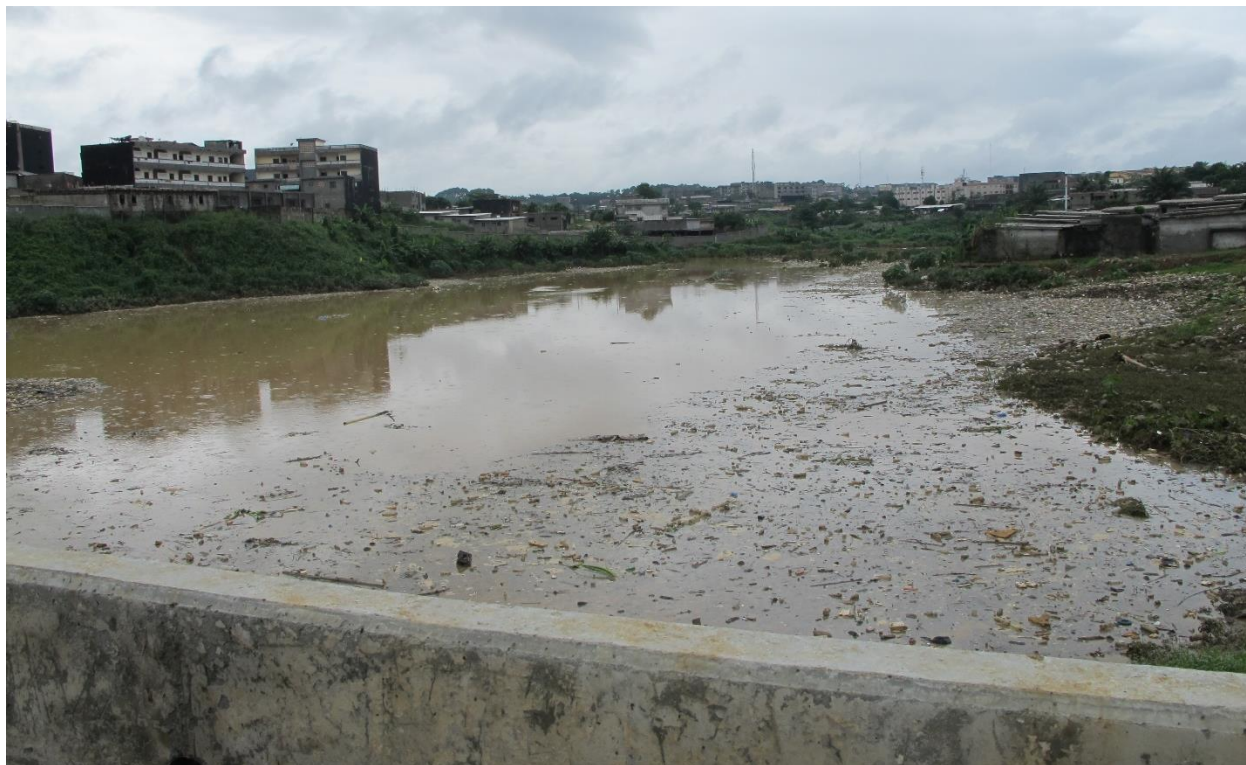
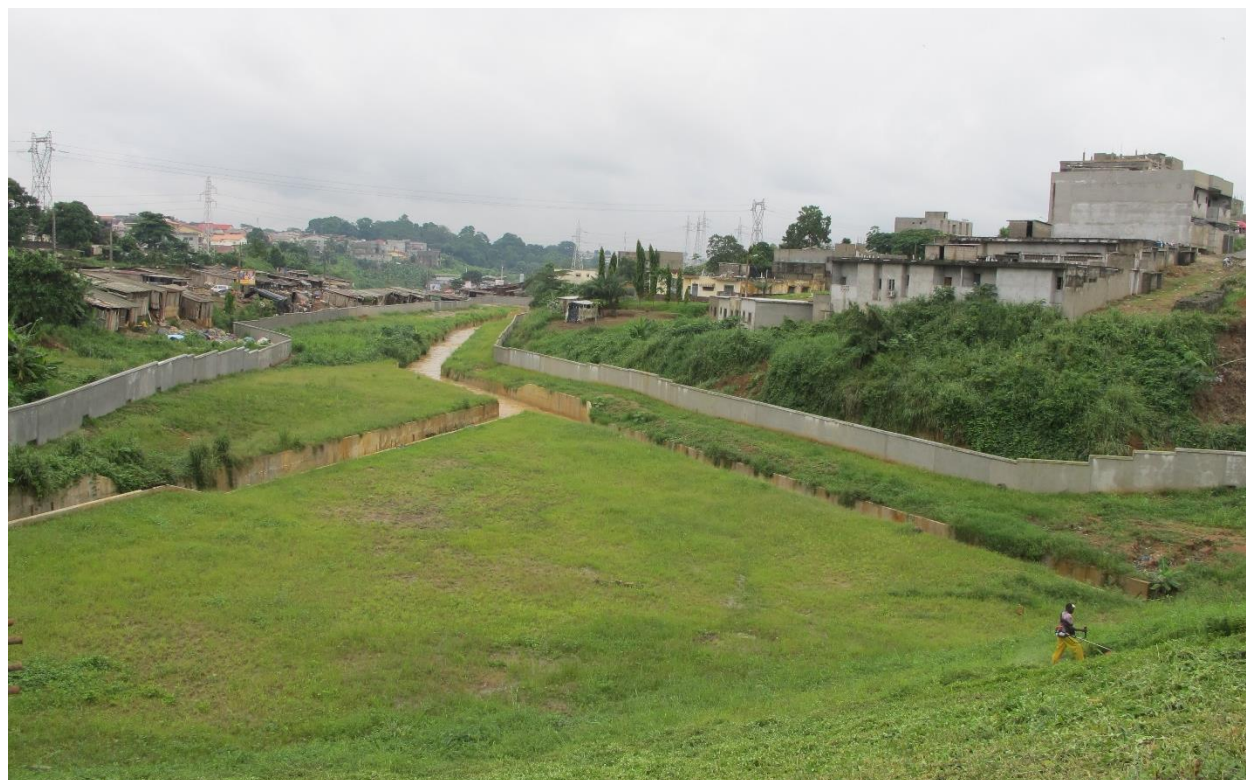
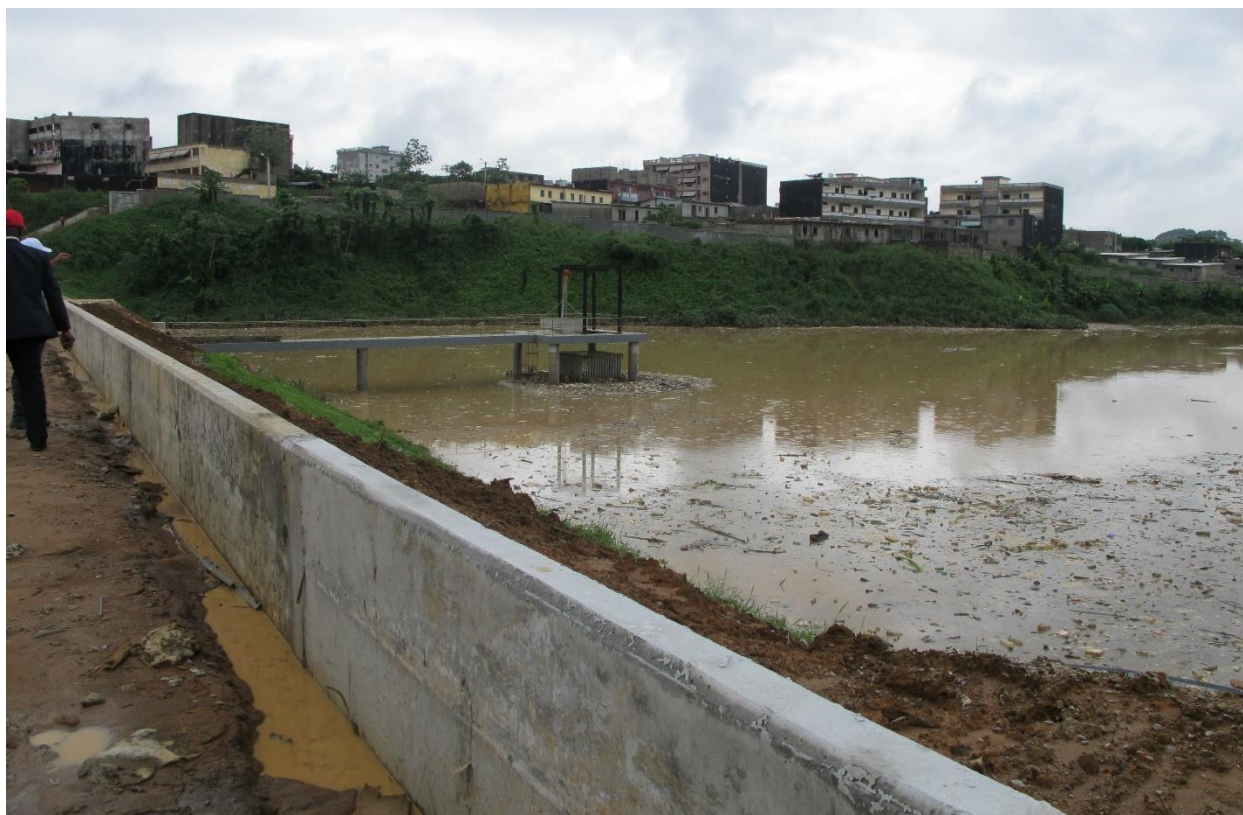
## Site Photos

The spill site is located off the express way linking Adjamé and Abobo, and consists of a rainwater holding basin that has been completely re-engineered since the time of the dumping, and recently provided with a concrete dam, base and drainage channels. Wastes from the Probo Koala were reported to have been dumped directly into the basin. Remediation work conducted by Trédi in 2006-2007 included pumping contaminated water and excavating sediments from the basin for off-site treatment. At the time of sampling the water within the basin was almost completely covered with a thick layer of predominantly plastic waste, comprising mainly of soft-drink bottles and plastic bags.

The laboratory results show that the current concentrations of the contaminants of concern in soil are all below the standards set by the Government of Côte d'Ivoire for clean-up. Likewise, hydrocarbon levels in the sample analysed are well below Dutch intervention values. Furthermore, the pH values are not in the caustic range (9 or above), demonstrating that the impact of the disposal of caustic substances can no longer be detected. No further action is therefore needed on this site to remediate the soil impacts of the 2006 toxic waste dumping from the Probo Koala.
