***Maziwi Island off Pangani (Tanzania):***

***History of its destruction and possible causes***

***UNEP Regional Seas Reports and Studies No. 139***

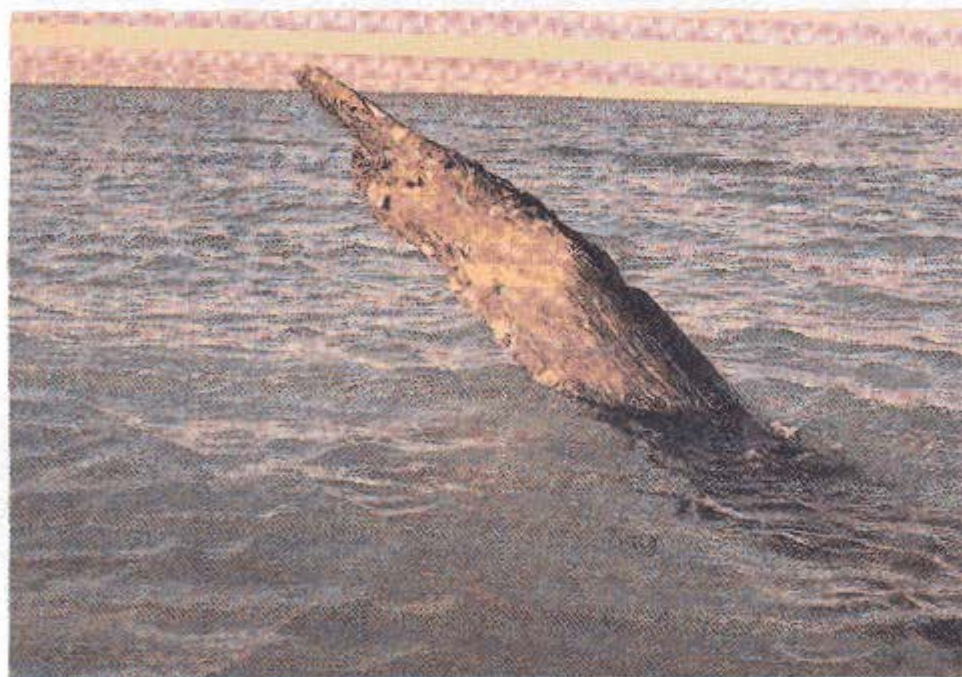
**Fig. 24**

In the vicinity of the sand spit, remains of trees, some of them more than 6 metres long, give evidence of a former vegetational cover of Maziwi Island. The wood of the stems is in an advanced stage of decay, intensively drilled and penetrated by marine organisms (mainly *Teredo* sp.). Some of the stems still show parts of the roots, indicating that the trees were not cut by people, but fell into the sea due to erosion.

- Fig.23: Fishermen still use Maziwi Island for stop-overs. Note the remnants of trees (shown in figs.24,25) in the water to the right of the boat.
- Figs.24,25: Stems of *Casuarina* trees on the northern side of the sand spit give evidence of the former vegetation on Maziwi Island. These remains of trees are found in large numbers all around the sand spit.
